Professional Home Inspection Service

Sample Home Inspection Report
Prepared for:

Inspection Date: 2/7/2000

Job Number: 00001

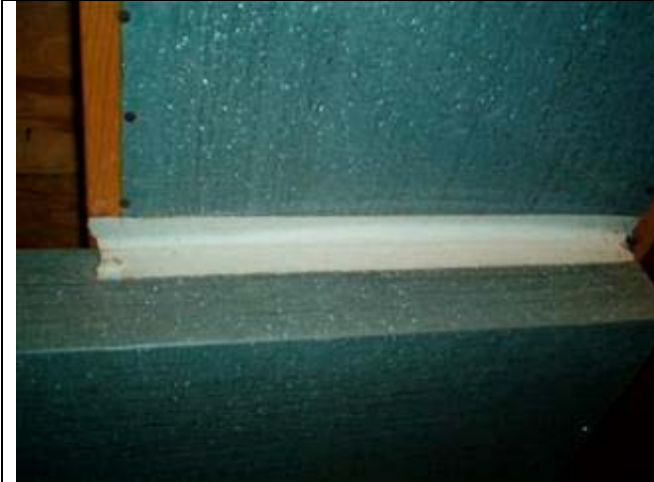
Suspected asbestos duct tape in basement

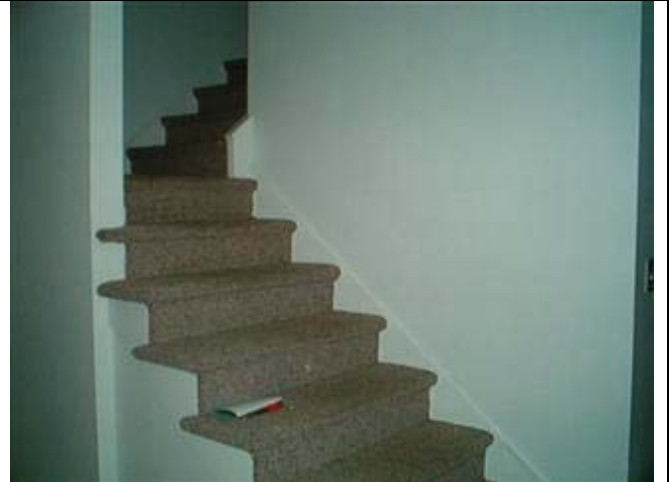
Example of missing rails and an open side at stairs

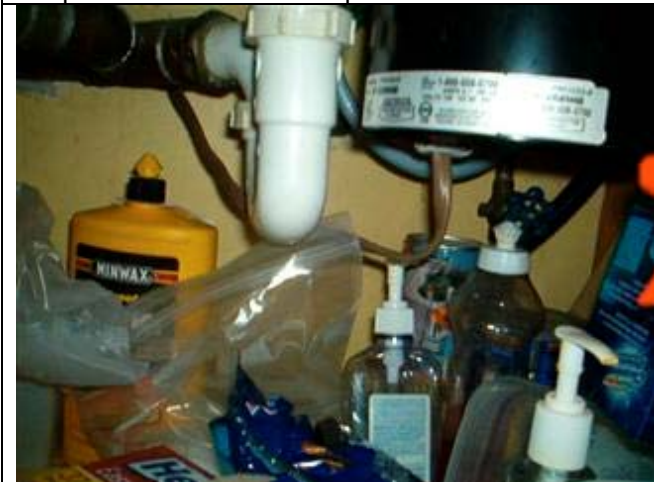
Unprotected wire to garbage disposal

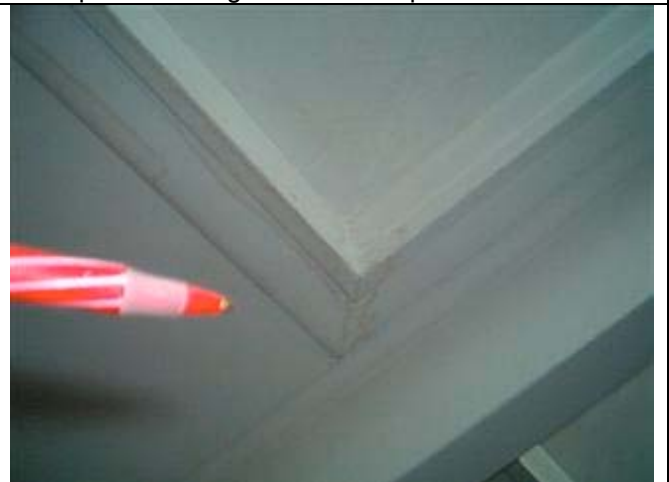
- **Stains on the skylight moldings are indications of likely leakage in the past. While these stains appeared to be dry at the time of inspection, the skylight frames have been heavily caulked and shingles have been piled at the top edge of the skylights, possibly to help divert water. We recommend repairs or installation of permanent flashings as necessary.**
- **No indications of significant wear, such as advanced grit loss or cracking, were found on the roof coverings. The present layer of roofing material appears to have a remaining effective life of approximately twenty five years.**
- **The roof slope appears to be less than the generally accepted minimum for shingle application over the hot tub room. We were unable to determine if the proper water and ice barrier membrane was installed under these shingles. Monitoring is advised.**

Stains at skylight trim

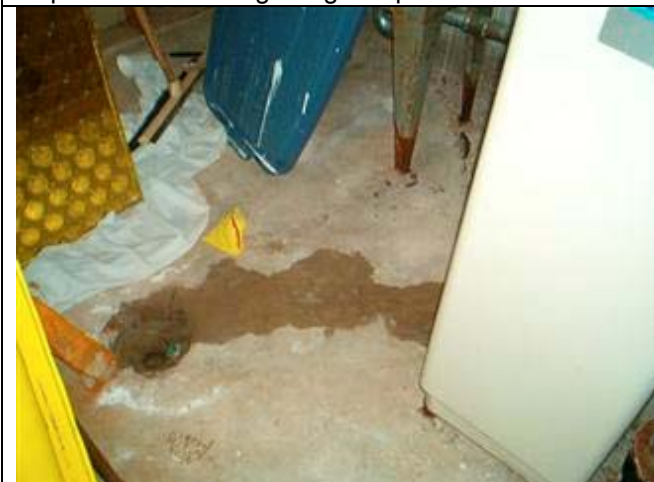
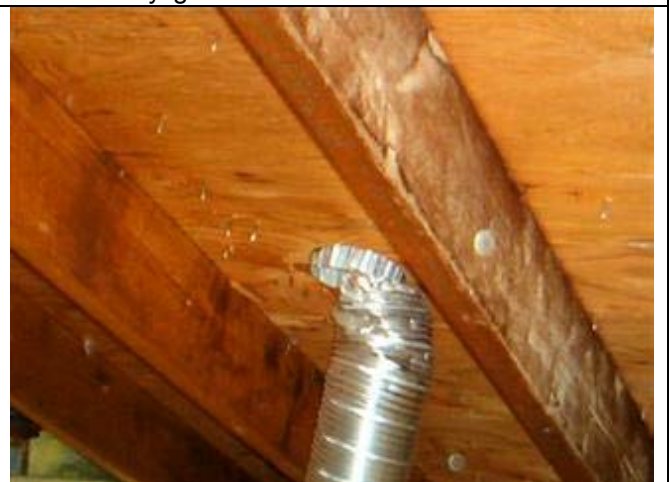
- **Water was observed on the basement floor adjacent to the water meter and water softener. The exact location of the leak was not determined. Further professional evaluation is recommended with repairs as necessary.**
- **The water heater has not received an appropriate add-on expansion tank subsequent to the installation of a backflow preventer on the municipal water supply. This results in excessive water**

Water on basement floor near water softener	Bath fan duct apart in attic
---	------------------------------

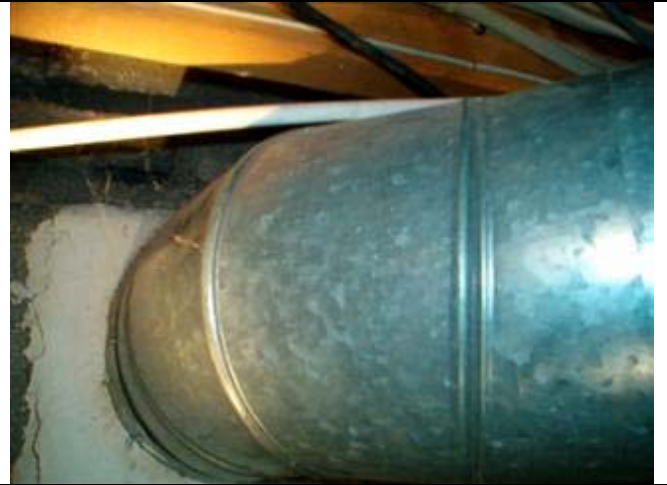
- The single wall vent connector does not maintain adequate clearance to combustible materials. The minimum accepted clearance for gas fired equipment is 6" unless otherwise indicated on the equipment or installation guide. About two inch clearance was observed between the connector and wood floor joists. We suggest installing double wall vent piping or heat shielding in the affected area as appropriate for increased safety.

Inadequate clearance from water heater vent to joists

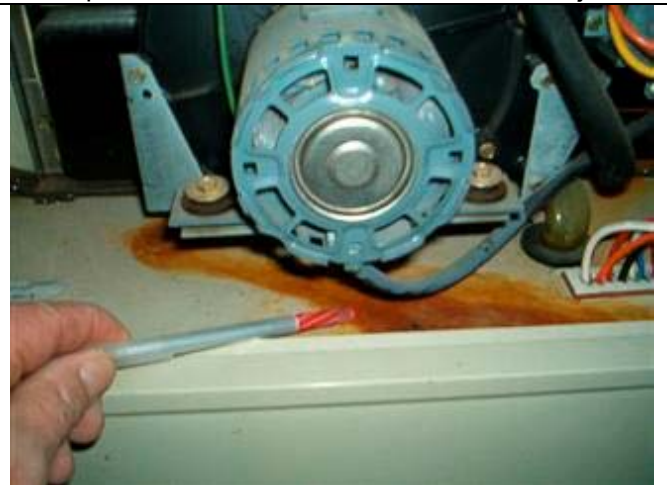
Corrosion in furnace cabinet

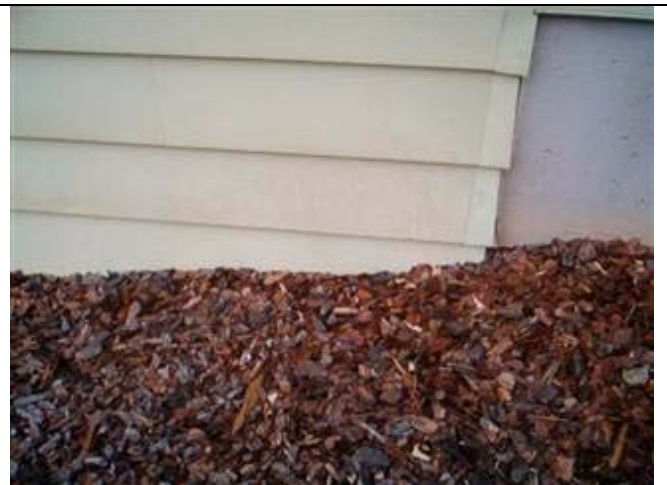
- **Exterior finishes were observed close to, or in contact with, the ground at the front and right sides. Siding and trim should be a minimum of 6" above grade to help ensure against moisture entry and decay to the siding or materials behind the siding.**

Example of soil/siding contact

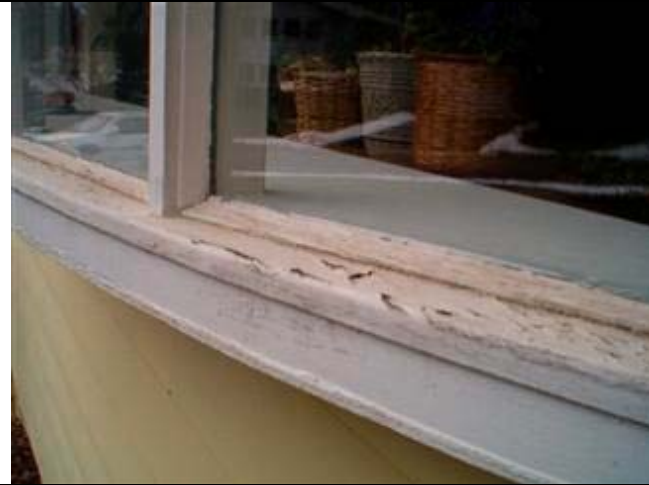
- **Areas of peeling paint were observed on the wooden trim. Periodic repainting is advised.**
- **A small amount of damaged aluminum siding was observed adjacent to the garage door opening.**

Example of peeling exterior paint

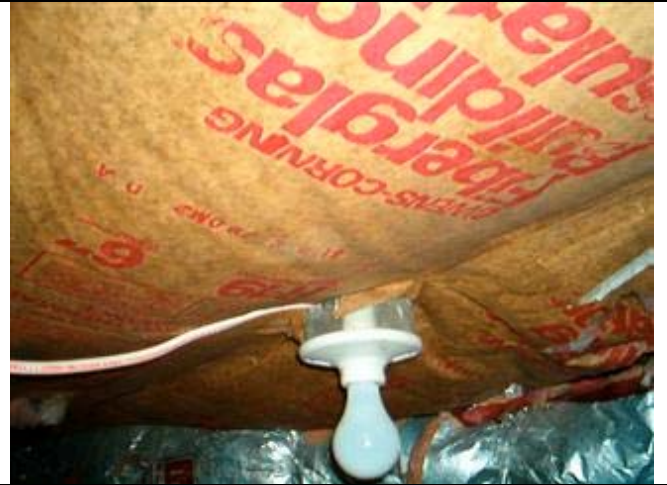
Insulation upside down in crawlspace with paper exposed

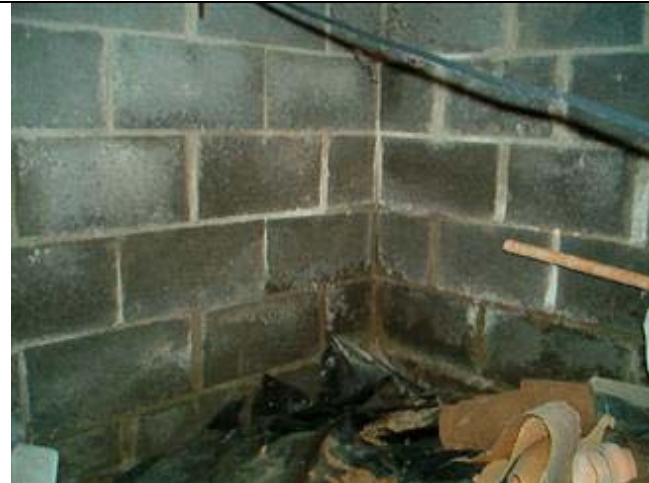
- **The crawlspace was damp at the time of inspection.**
- **To help reduce or prevent any future water entry in the crawlspace or basement, we recommend repairing and adjusting the gutters where sagging at the front of the house and repairing or relocating gutter downspouts, or adding tailpiece extensions where needed to improve drainage.**

Damp conditions in crawlspace

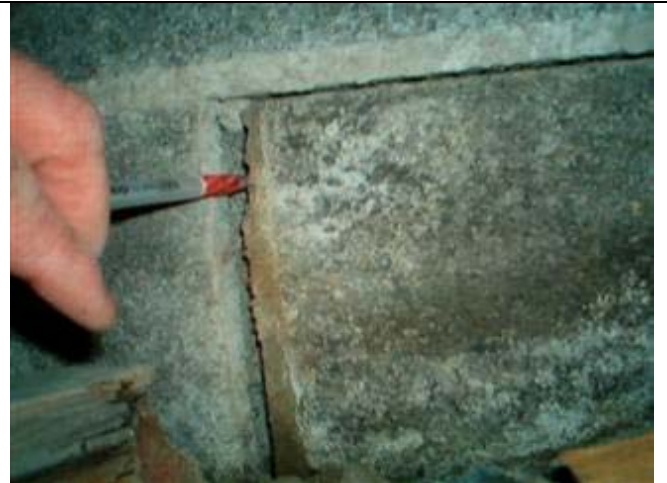
- **There is evidence of some inward movement associated with one or more observed cracks in the first floor bedroom/office crawlspace foundation. This is often the result of excess moisture and frost in the adjacent soil. Reducing the concentration of water in the adjacent soil should help prevent further movement. Installing a gutter downspout extension in this area should be helpful. No evidence of significantly compromised support was found in relation to the movement noted. Sealing and monitoring of the crack(s) is recommended.**

Crack and offset in crawlspace foundation

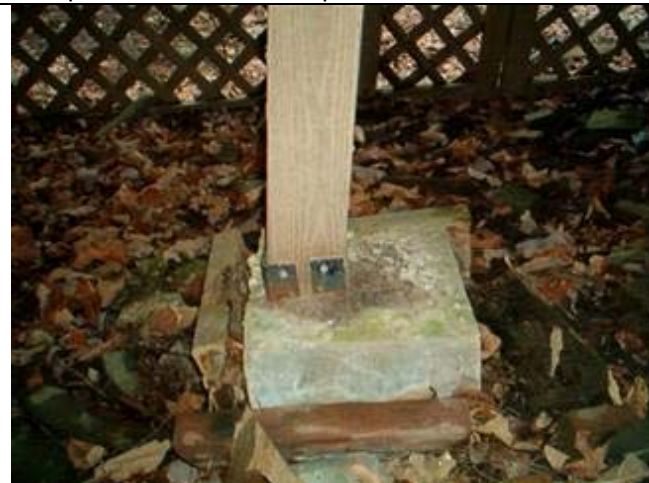
- **Some minor settling has occurred in the concrete footers at the rear deck support posts. While this settling has moved the posts somewhat out of plumb, no indications of significantly compromised support was observed. Monitoring for any future movement is advised.**

Settled footer, post out of plumb under deck

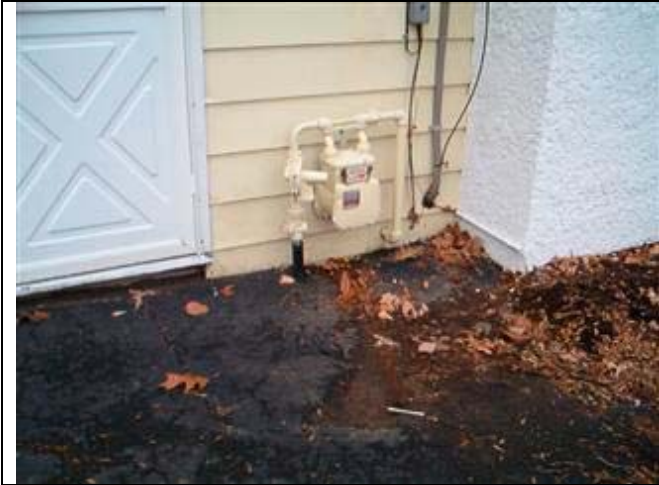
Gas meter unprotected at driveway

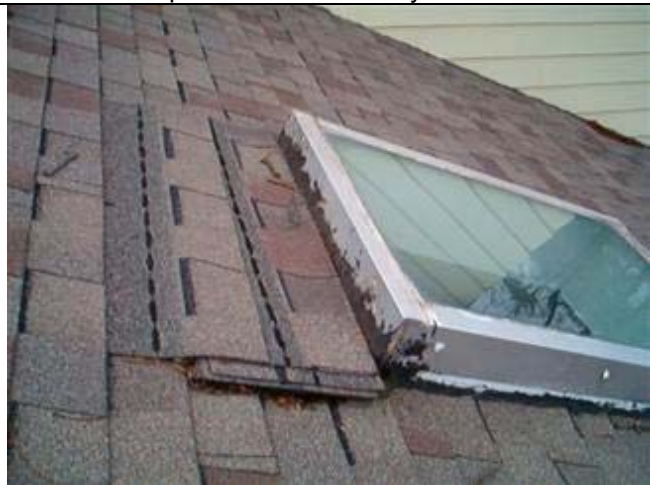
Shingles piled above skylight

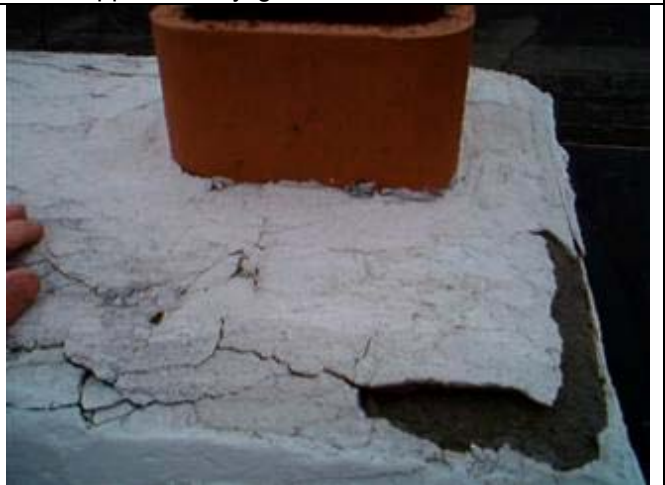
- **Deterioration and/or cracking of the crown has been noted at the masonry chimney. This can result in moisture entry into the masonry and subsequent damage. Recoating the stucco on this crown is recommended.**
- **A gas insert has been installed in the fireplace, preventing inspection of the fireplace for use with solid fuel. See HEATING EQUIPMENT.**

Deterioration on chimney crown

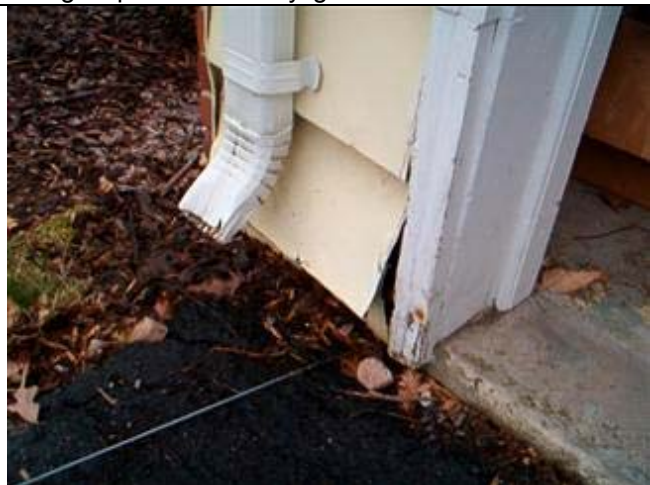
Example of downspout discharging adjacent to house
