Professional Home Inspection Service

Sample Home Inspection Report
Prepared for:

Inspection Date: 2/7/2000

Job Number: 00001

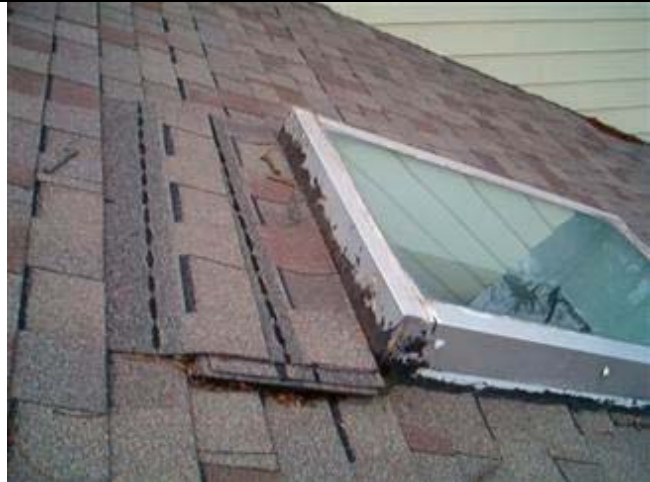
- **Stains on the skylight moldings are indications of likely leakage in the past. While these stains appeared to be dry at the time of inspection, the skylight frames have been heavily caulked and shingles have been piled at the top edge of the skylights, possibly to help divert water. We recommend repairs or installation of permanent flashings as necessary.**
- **No indications of significant wear, such as advanced grit loss or cracking, were found on the roof coverings. The present layer of roofing material appears to have a remaining effective life of approximately twenty five years.**
- **The roof slope appears to be less than the generally accepted minimum for shingle application over the hot tub room. We were unable to determine if the proper water and ice barrier membrane was installed under these shingles. Monitoring is advised.**

Shingles piled above skylight

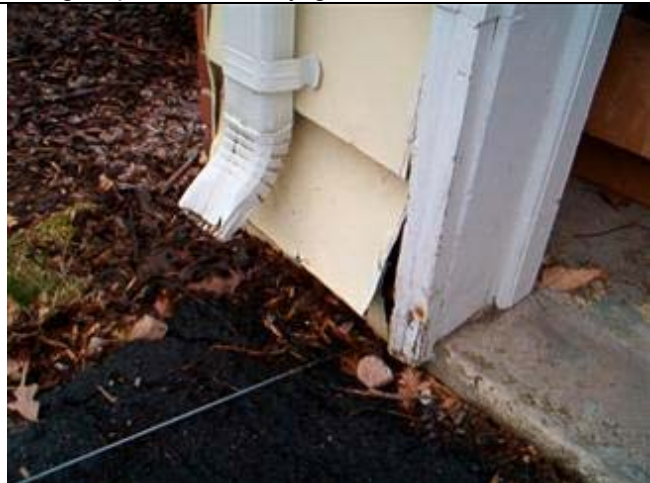
Example of downspout discharging adjacent to house
