# Professional Home Inspection Service

Sample Home Inspection Report  
Prepared for:

Inspection Date: 2/7/2000

Job Number: 00001

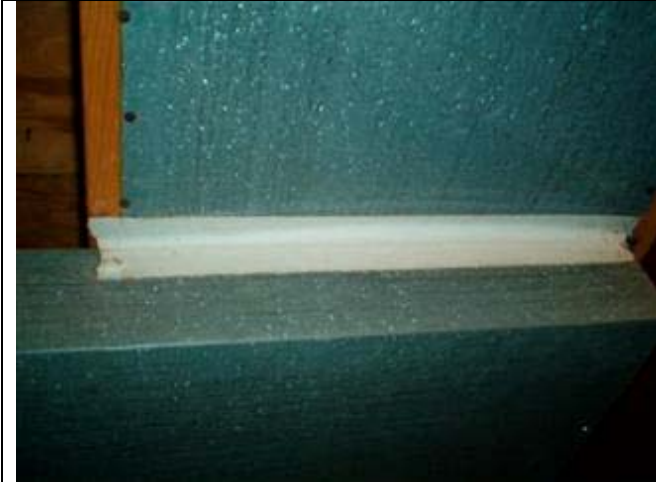
Suspected asbestos duct tape in basement

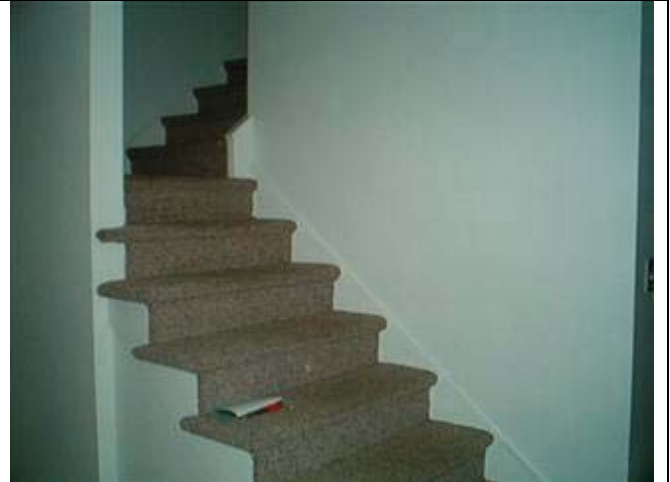
- **A corner roof support post has been removed at the front porch. Resultant sagging was observed at this roof. Repair is advised.**
- **Safety railings are missing at both interior stairs and at the front porch. An open side without a handrail installed for improved safety was also observed at the interior stairs.**
- **Settling, resulting in an excessive rise and possible trip hazard, has occurred where the front walk meets the porch steps.**
- **Evidence of past or present small rodent activity was observed. A dead mouse was observed in the basement near the utility sink.**
- **No continuous flashing has been installed from behind the siding over or behind the adjacent deck framing to prevent water entry to behind the siding below the deck. Stains that were observed on the**

Example of missing rails and an open side at stairs

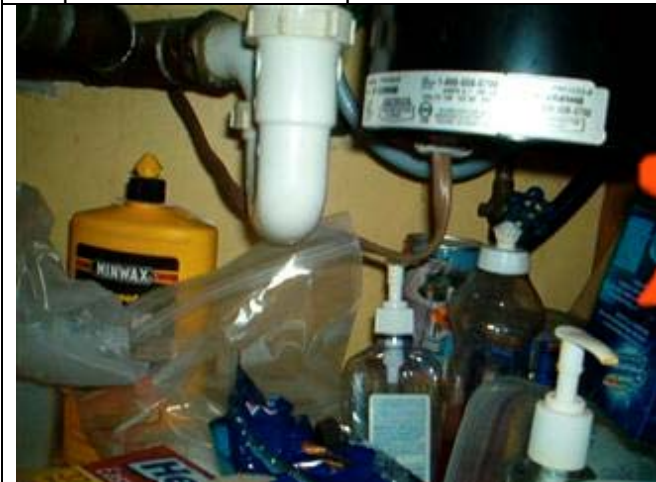
Unprotected wire to garbage disposal

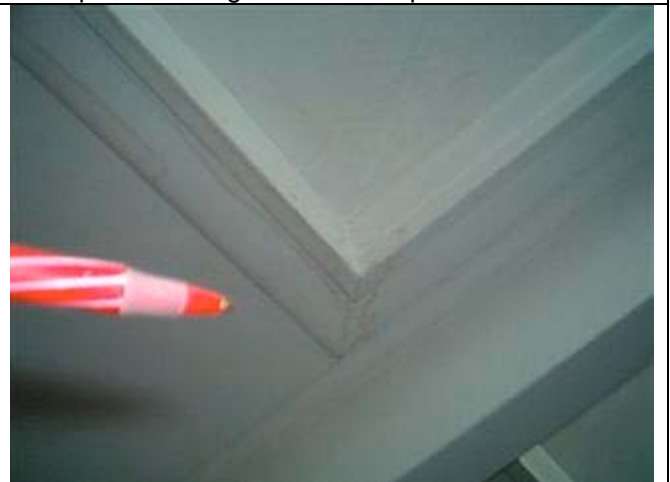
- **Stains on the skylight moldings are indications of likely leakage in the past. While these stains appeared to be dry at the time of inspection, the skylight frames have been heavily caulked and shingles have been piled at the top edge of the skylights, possibly to help divert water. We recommend repairs or installation of permanent flashings as necessary.**
- **No indications of significant wear, such as advanced grit loss or cracking, were found on the roof coverings. The present layer of roofing material appears to have a remaining effective life of approximately twenty five years.**
- **The roof slope appears to be less than the generally accepted minimum for shingle application over the hot tub room. We were unable to determine if the proper water and ice barrier membrane was installed under these shingles. Monitoring is advised.**

Stains at skylight trim

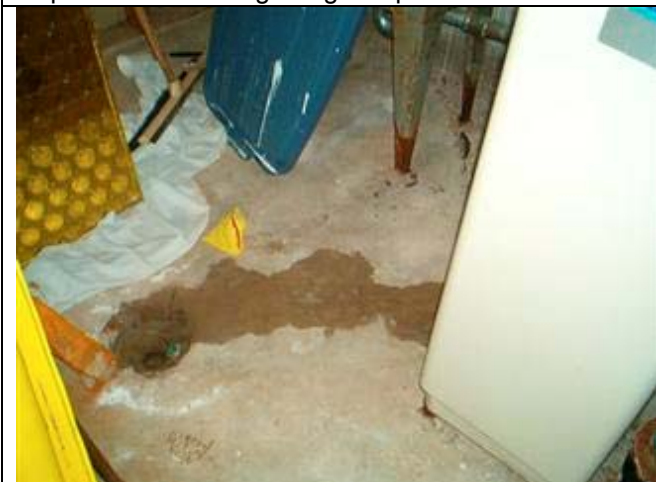
- **Water was observed on the basement floor adjacent to the water meter and water softener. The exact location of the leak was not determined. Further professional evaluation is recommended with repairs as necessary.**
- **The water heater has not received an appropriate add-on expansion tank subsequent to the installation of a backflow preventer on the municipal water supply. This results in excessive water**

Water on basement floor near water softener	Bath fan duct apart in attic
---	------------------------------

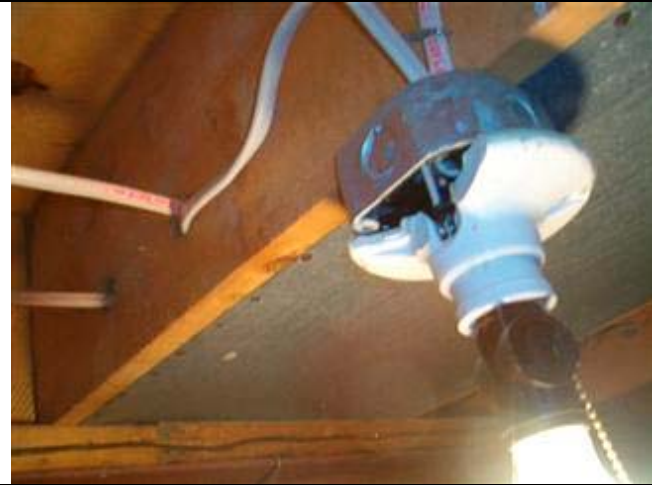
Broken light fixture above basement workbench

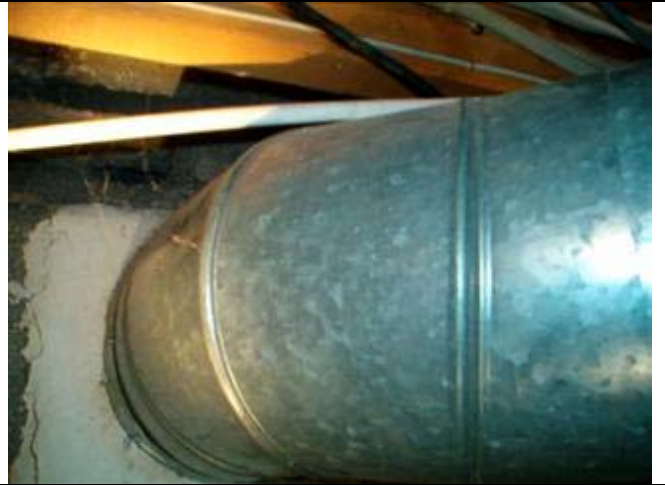
- The single wall vent connector does not maintain adequate clearance to combustible materials. The minimum accepted clearance for gas fired equipment is 6" unless otherwise indicated on the equipment or installation guide. About two inch clearance was observed between the connector and wood floor joists. We suggest installing double wall vent piping or heat shielding in the affected area as appropriate for increased safety.

Inadequate clearance from water heater vent to joists

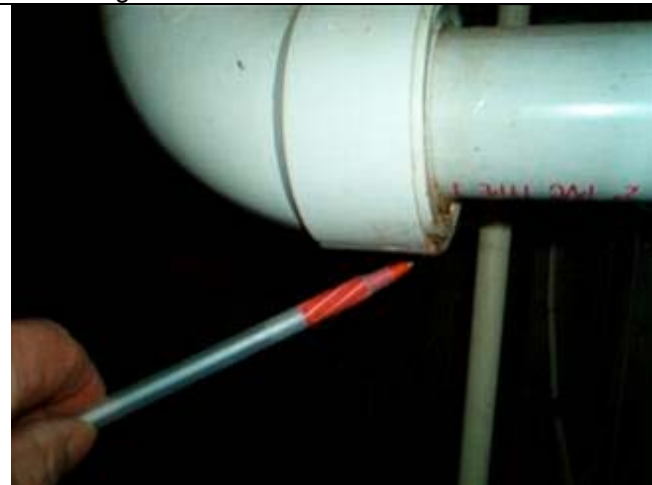
Active leak at furnace vent piping

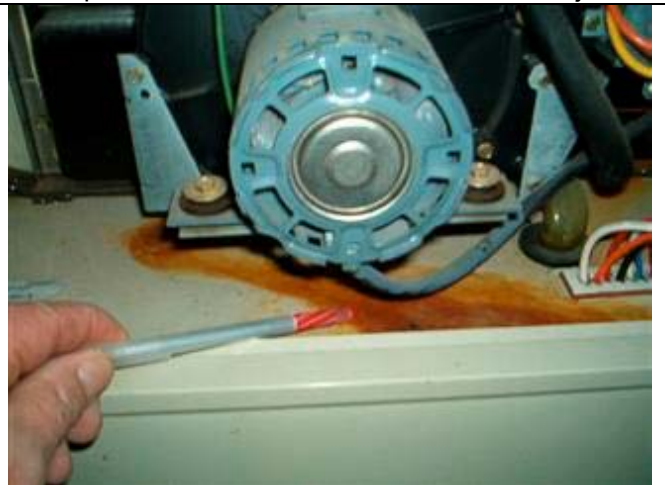
Corrosion in furnace cabinet

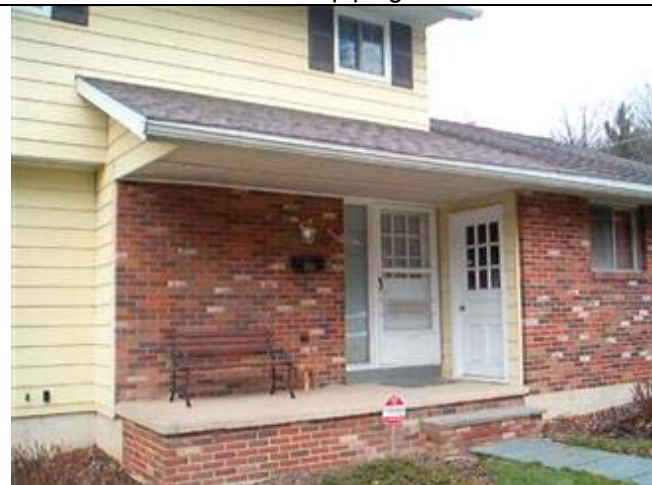
Missing corner post at porch roof, missing rails, excessive rise at step

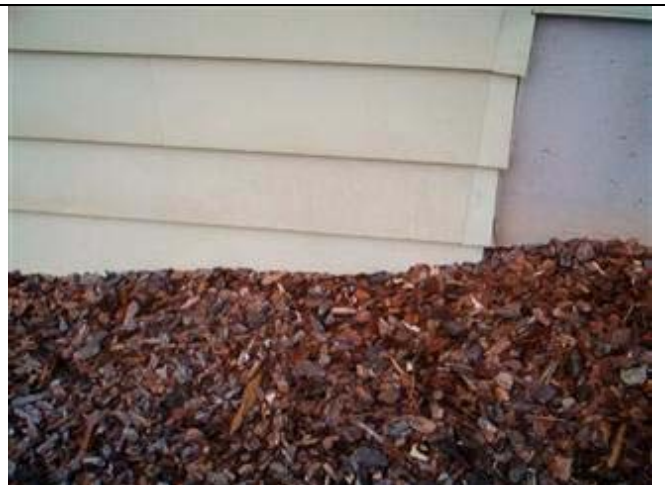
- **Exterior finishes were observed close to, or in contact with, the ground at the front and right sides. Siding and trim should be a minimum of 6" above grade to help ensure against moisture entry and decay to the siding or materials behind the siding.**

Example of soil/siding contact

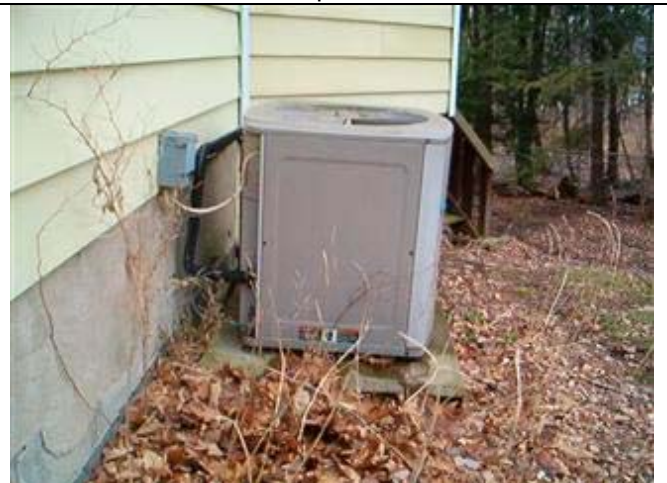
Air conditioner unit out of level

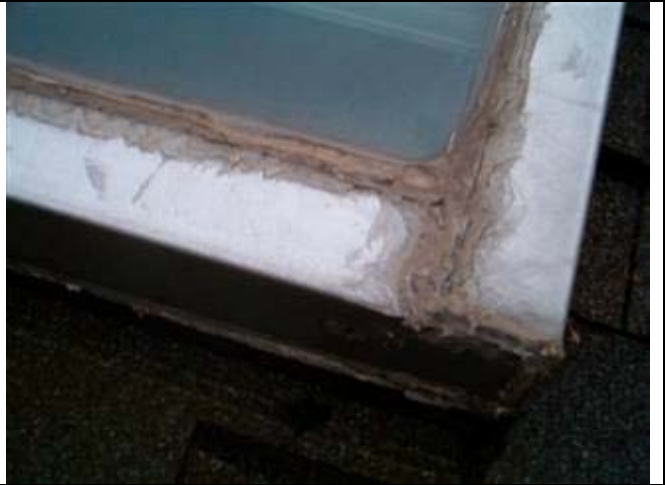
Caulk applied to skylight

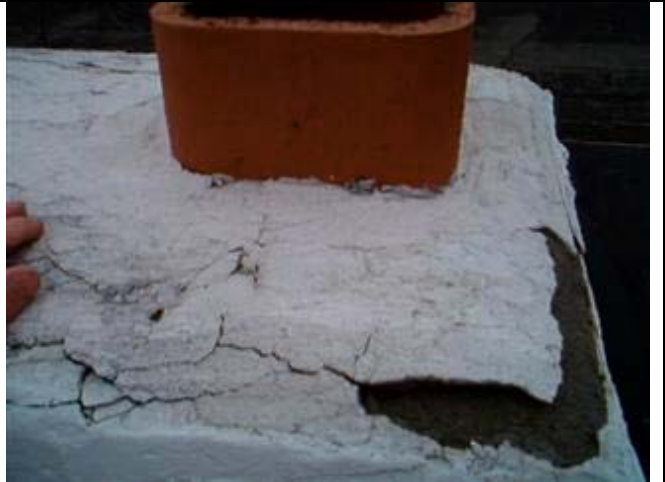
- **Deterioration and/or cracking of the crown has been noted at the masonry chimney. This can result in moisture entry into the masonry and subsequent damage. Recoating the stucco on this crown is recommended.**
- **A gas insert has been installed in the fireplace, preventing inspection of the fireplace for use with solid fuel. See HEATING EQUIPMENT.**

Deterioration on chimney crown
